Comfort lift jamming in upper position

AEG

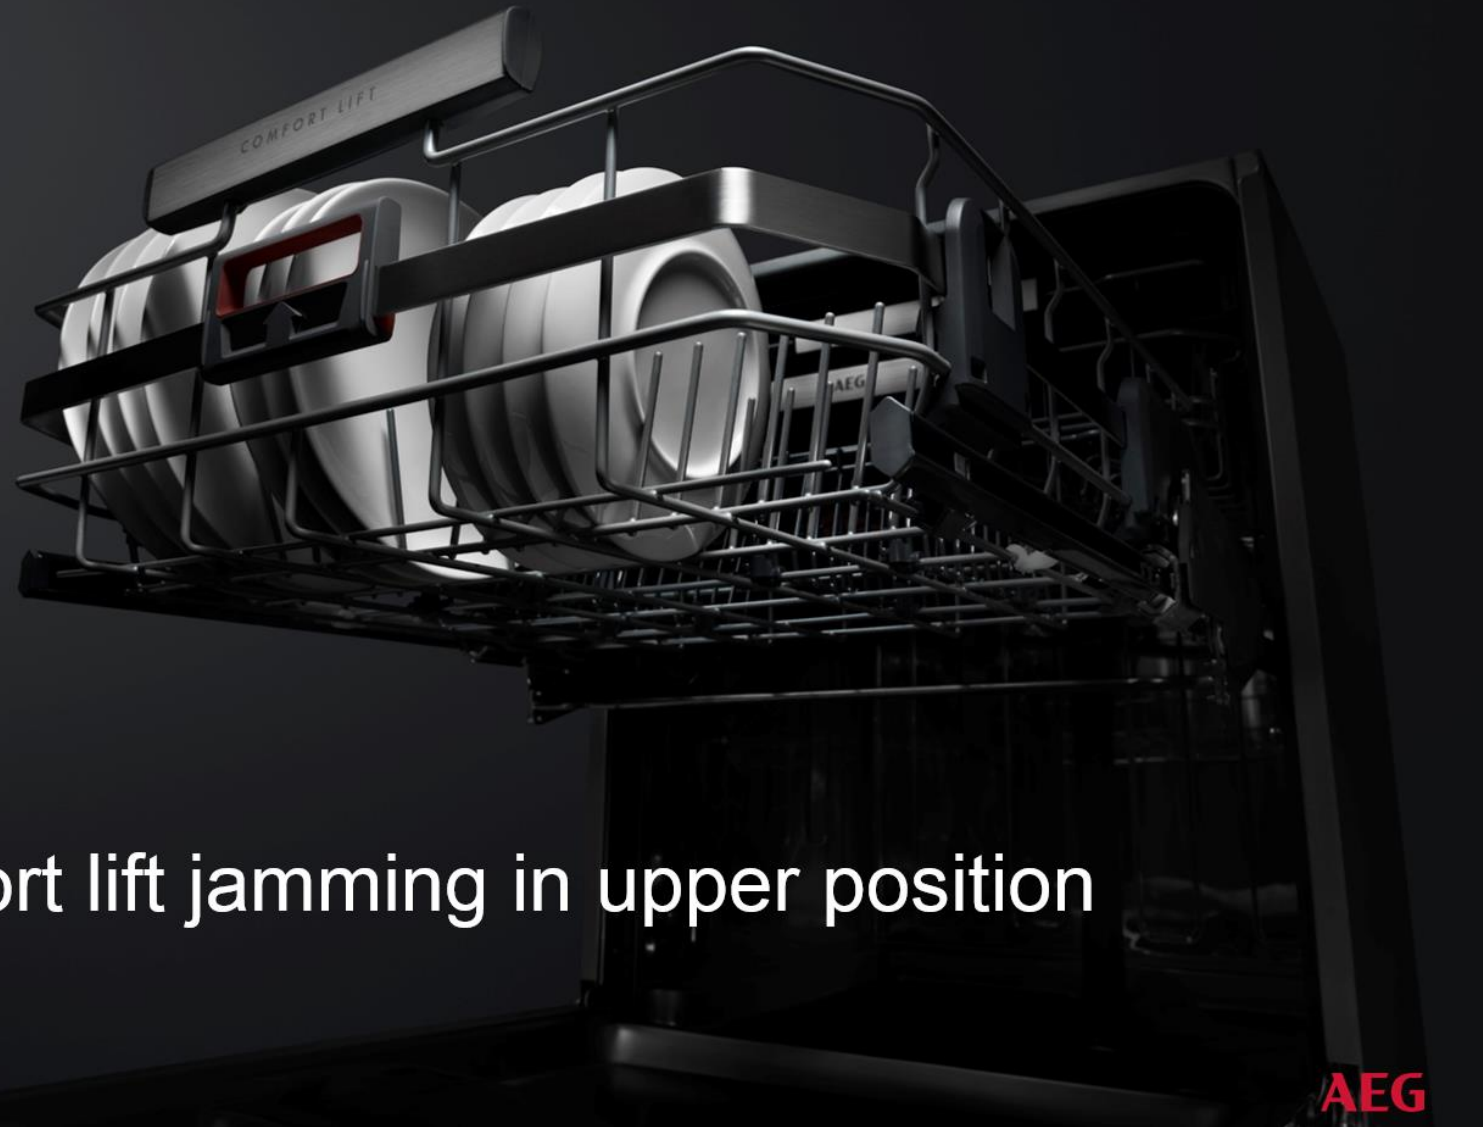
Correct

White
guide
pin in
channel

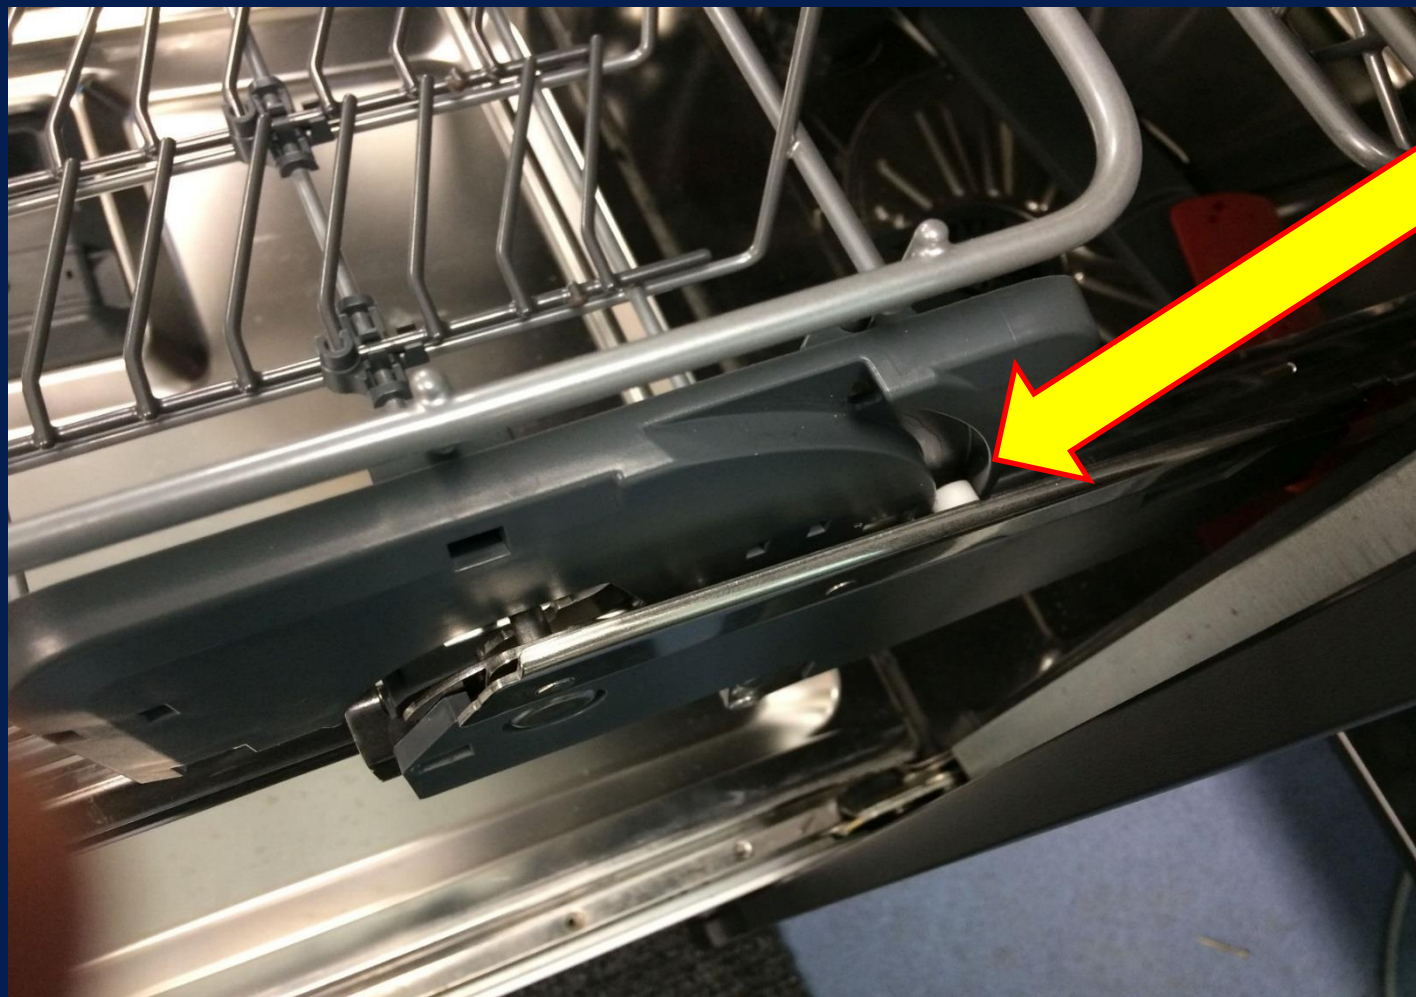
R/H side:

Correct

White
guide
pin in
channel

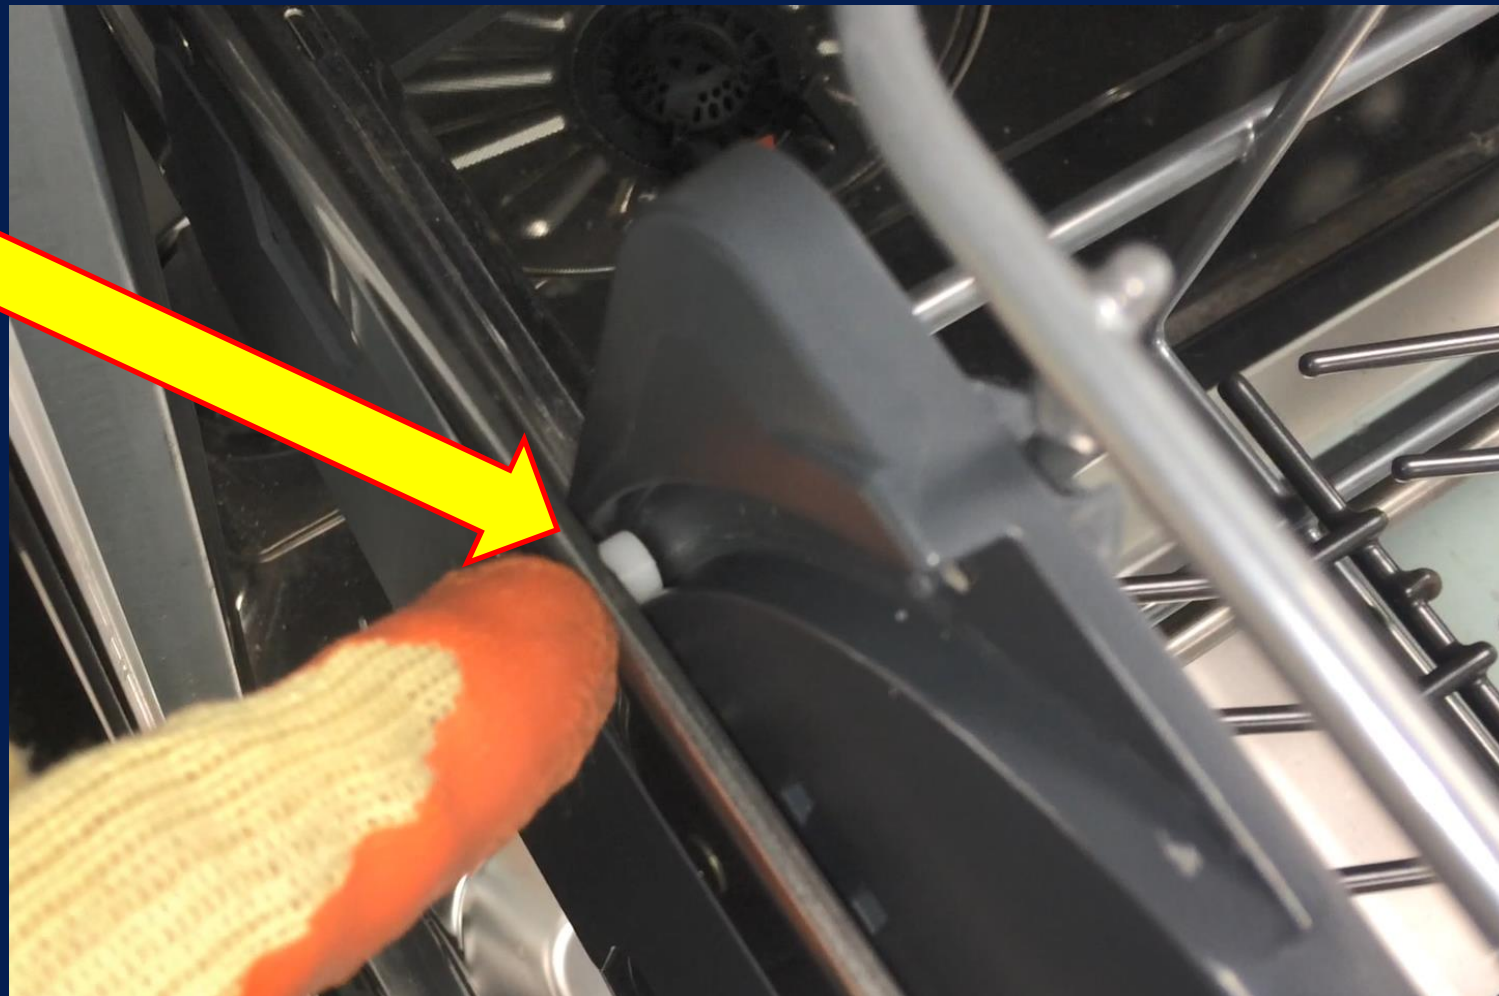
L/H side:

Incorrect

White
guide pin
not in
channel

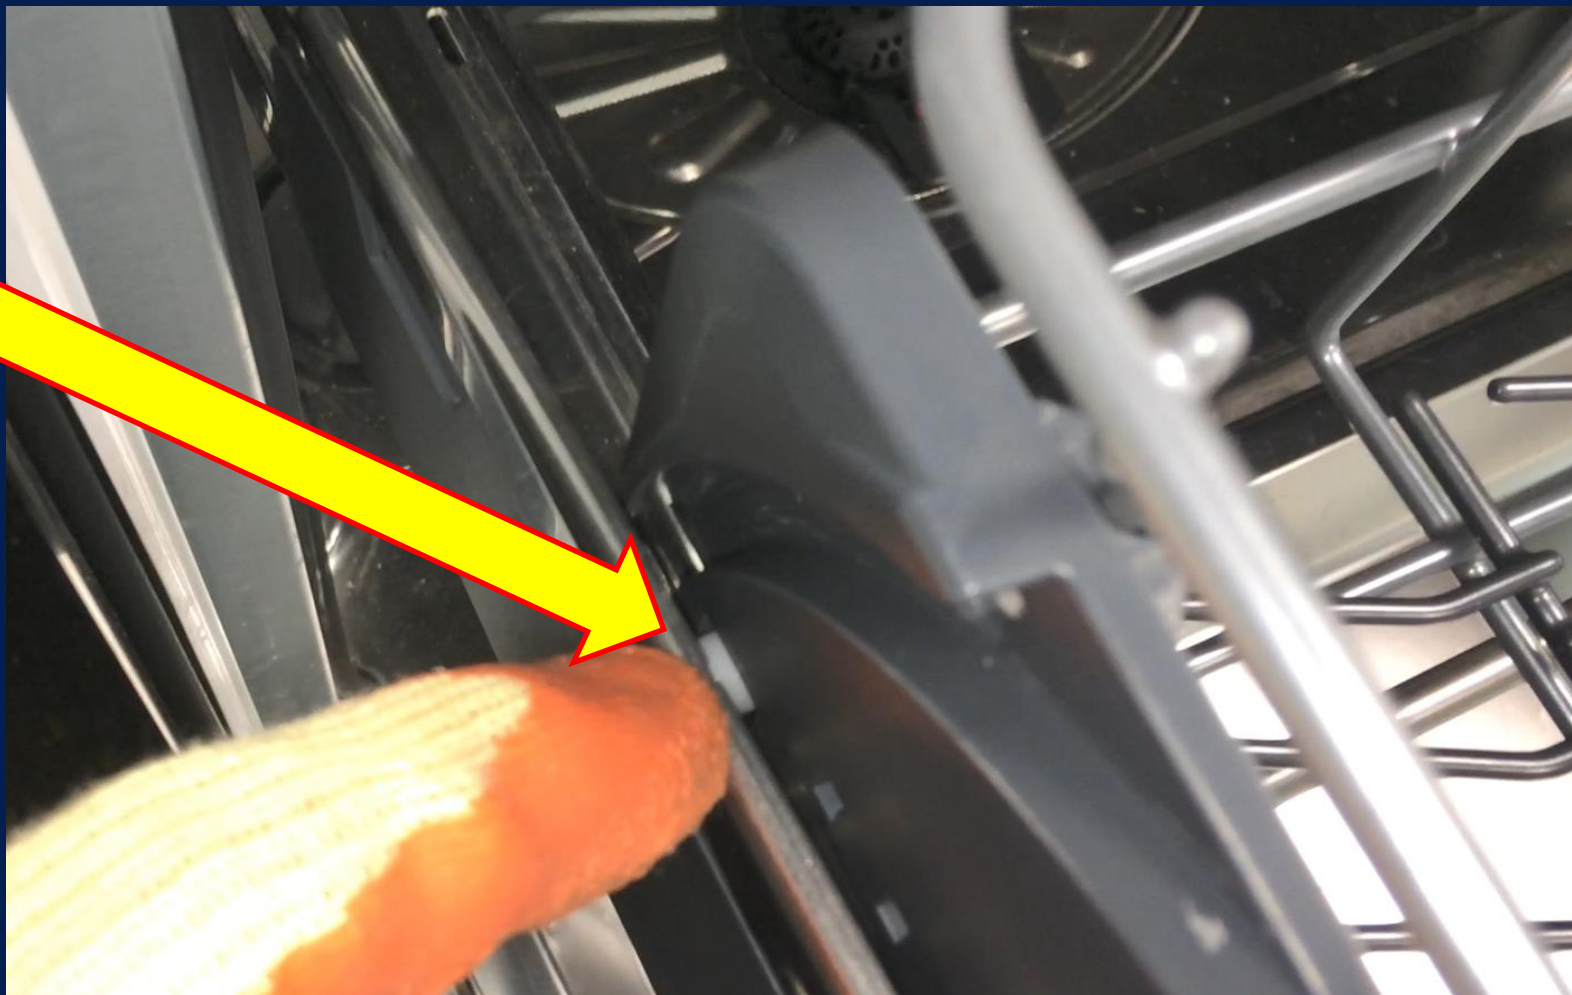
L/H side:

Incorrect

White
guide pin
not in
channel

White guide
pin dropped
into adjacent
slot
